ENVIRONMENTAL ASSESSMENT AND FINDING OF NO SIGNIFICANT IMPACT NAVIGATION IMPROVEMENTS PORT LIONS, ALASKA

July 2005

Navigation Improvements Environmental Assessment Port Lions, Alaska

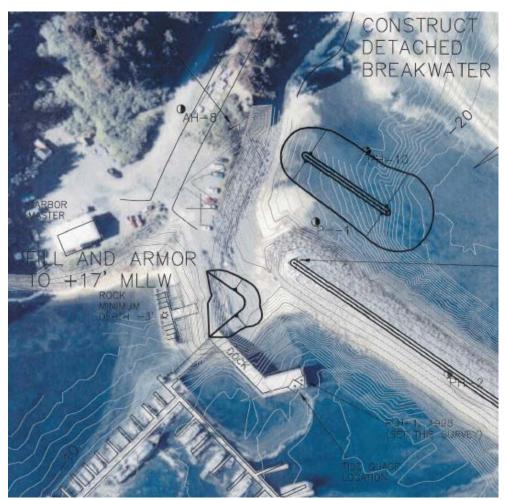
Figure 5. Breach Alternative A.

Breach Alternative A, shown in figure 5, would consist of a 150-foot-long detached breakwater and a 75-foot extension of the stub breakwater. The opening between the detached breakwater and shoreline would form a 30-foot breach. The opening between the main and stub breakwaters would be reduced from 65 to 30 feet. The invert elevations through the breach would remain the same at +5 feet MLLW. No dredging would be required. The specifications for this alternative are in table. 4

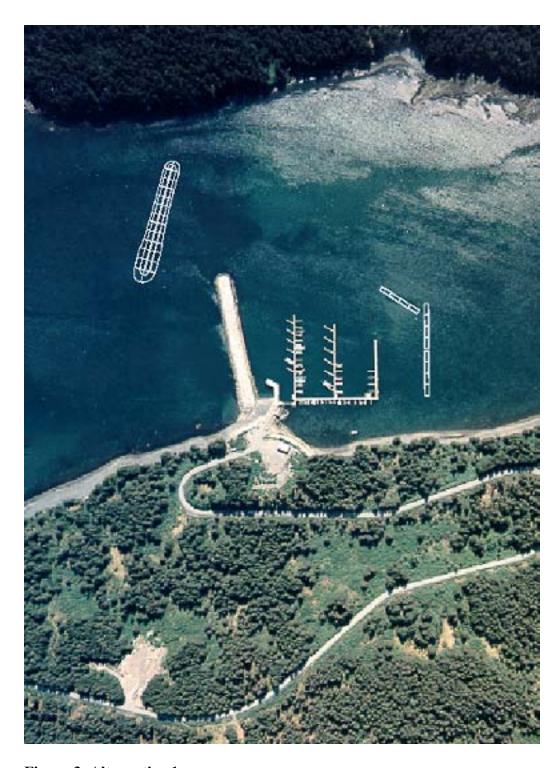
Figure 3. Alternative 1a.

Alternative 1a (Figure 3) involves construction of a rubblemound breakwater located northeast of the existing breakwater and replacement of the existing floating breakwaters on the southeast side of the harbor with new floating breakwaters. The existing floating breakwater would be removed and disposed of at an upland site. No dredging would be required.

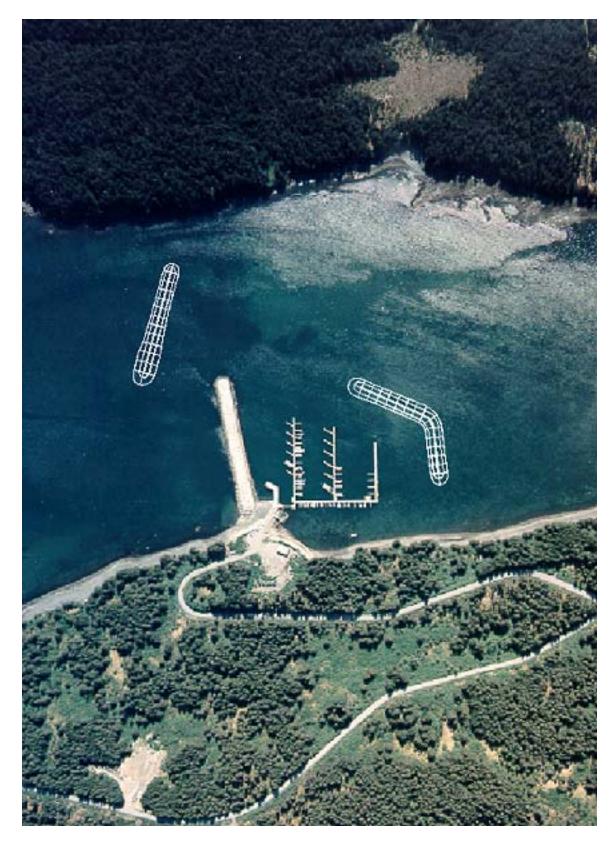
Figure 4. Alternative 1b.

Alternative 1b (Figure 4) would consist of two rubblemound breakwaters located northeast and southeast of the existing breakwater. The existing floating breakwater, replaced by one of the rubble mound breakwaters, would be removed and disposed of at an upland site. No dredging would be required.

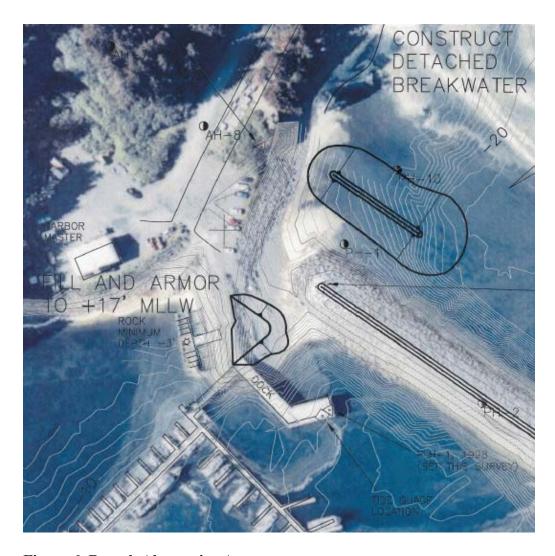
Figure 6. Breach Alternative A.

Breach Alternative A (Figure 6) involves construction of a 150-foot long detached breakwater and a 75-foot extension of the existing stub breakwater that is located adjacent to the dock. The opening between the proposed detached breakwater and shoreline would form a 30-foot breach. The opening between the main and stub breakwaters would be reduced from 65 to 30 feet. Invert elevations through the breach would remain the same at +5 feet, MLLW. No dredging would be required for this alternative.

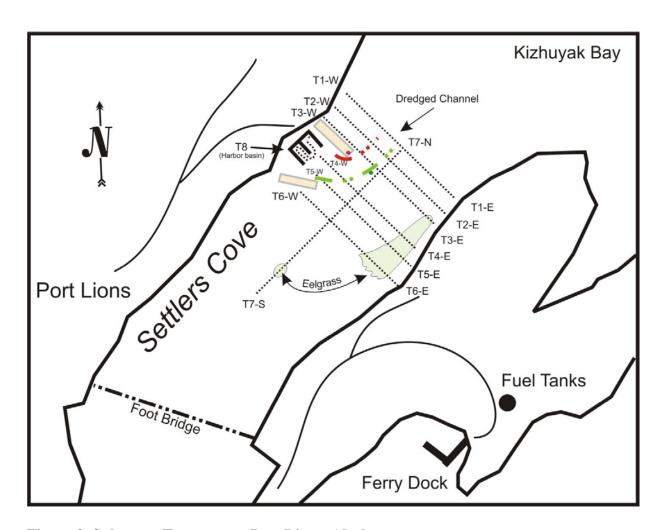
Figure 9. Substrate Transects at Port Lions, Alaska.

Note: Transects were videotaped on March 6, 2002.

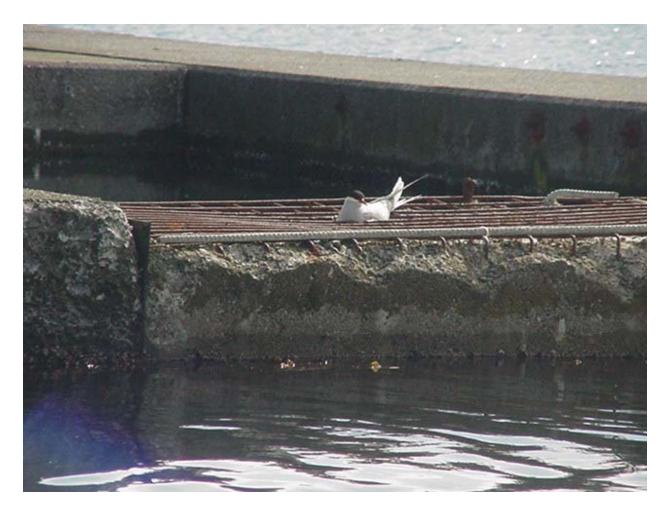
Figure 14. Arctic tern nest on floating breakwater.

No bald eagle nests were observed in the vicinity of the harbor during 2002 field investigations; however, numerous bald eagles were documented feeding and perching in the Settler Cove area. The nearest seabird colony is located approximately 3 miles from the harbor and supports 400 black-legged kittiwakes. One Arctic tern was documented nesting on the most eastern floating breakwater that runs parallel to the shoreline (Figure 14). The nest was on exposed rebar from
